Manhole Inspection Summary

Manhole # S35SS1001MH

Insp Date: **3/21/07 10:29 AM**

Location Address: **4501 UNDERWOOD RD**

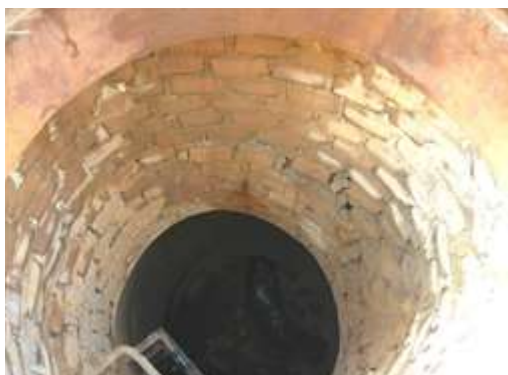
Defect

Barrel infiltration. Bench debris.

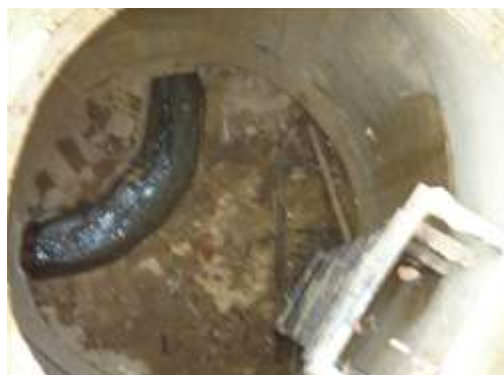
Defect

Frame leaks. Adjustment and Corbel deterioration and infiltration - other side.

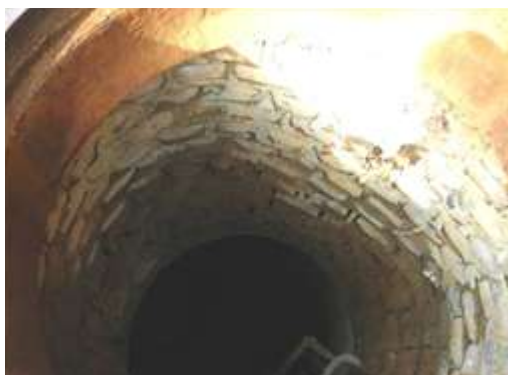
Defect

Barrel infiltration.

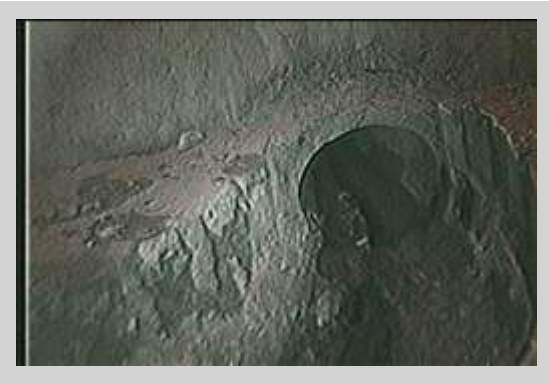
8 in. Circular Gravity Sewer Pipe Out @ 12 O'Clock

Invert Depth: **13.58** (ft.) Flow Characteristics: **Slow**

Infiltration: **None** Pipe Seal Cond: **Unknown**

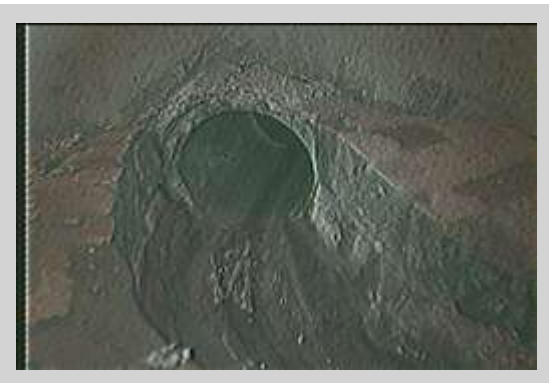
8 in. Circular Gravity Sewer Pipe In @ 9 O'Clock

Infiltration: **Evidence** Pipe Seal Cond: **Cracked**
